NSTX-U Recovery Project Review, Status and Plans

Presented at FESAC

February 1, 2017

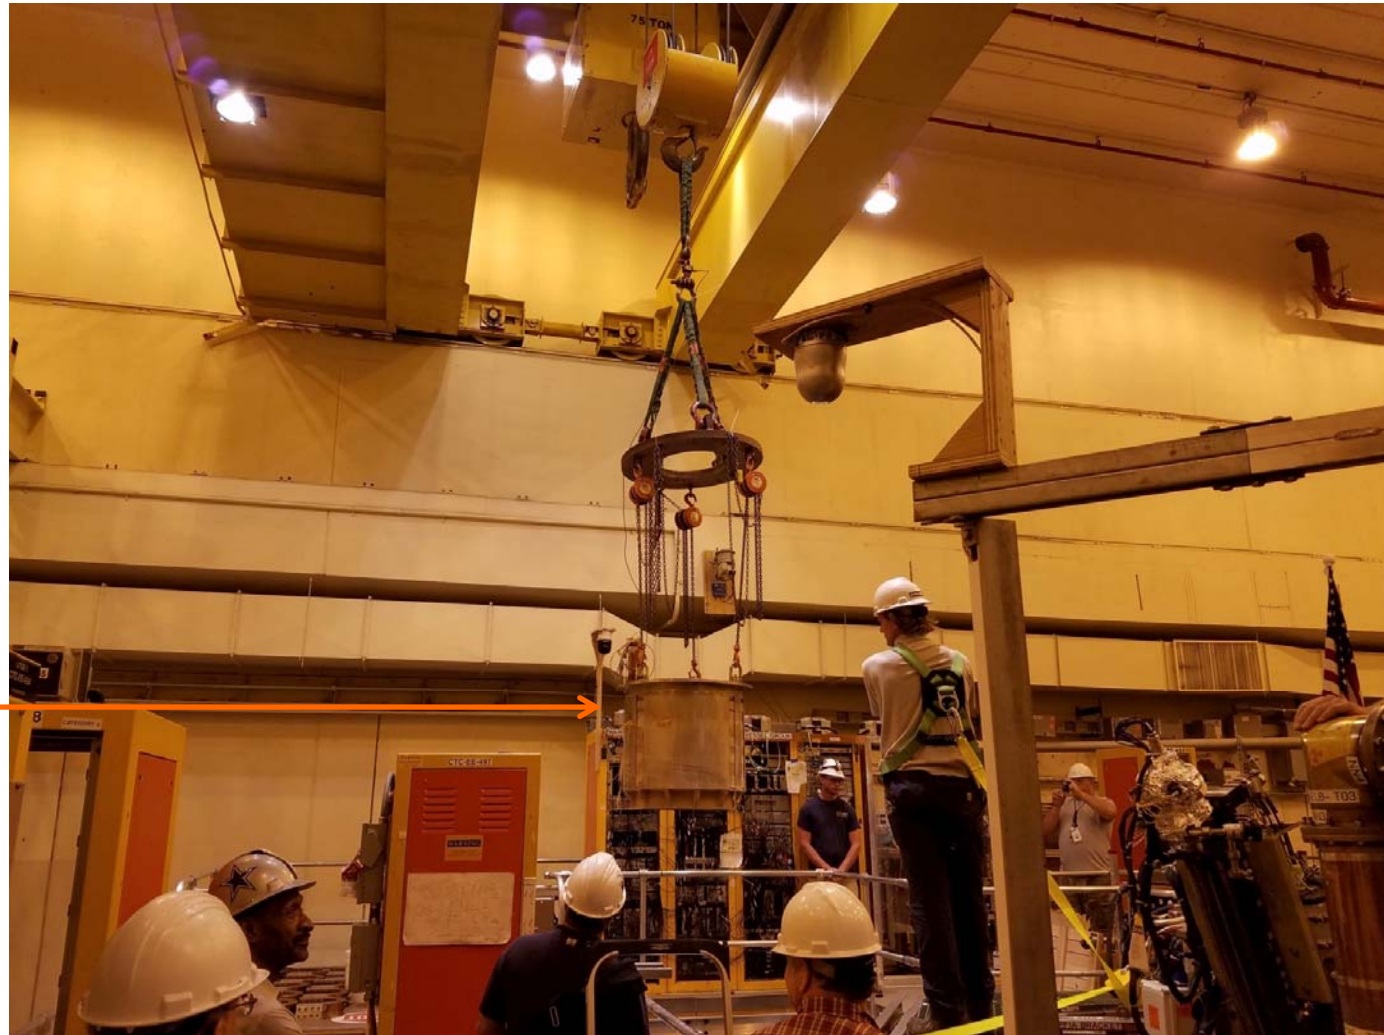
Removal of PF1A Upper Coil

- The design of the PF1-A coil is nearing completion.
 - PDR within the next two months
 - FDR within the next three months
- Evaluating different options for coil manufacturing:
 - PPPL
 - Industry
 - Other national laboratory
- Evaluating whether other coils should also be rebuilt.

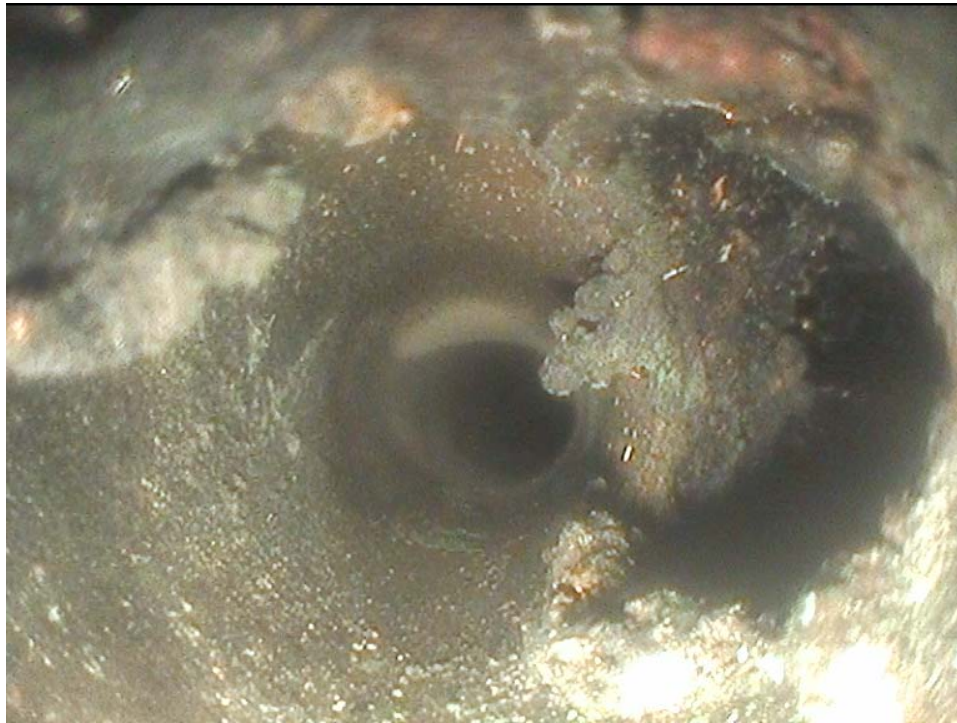
Section A-B, Layer 3, Row 9 Void Anomaly

Videoscope Shows Breach in Cooling Channel

- Dry glass found – not impregnated

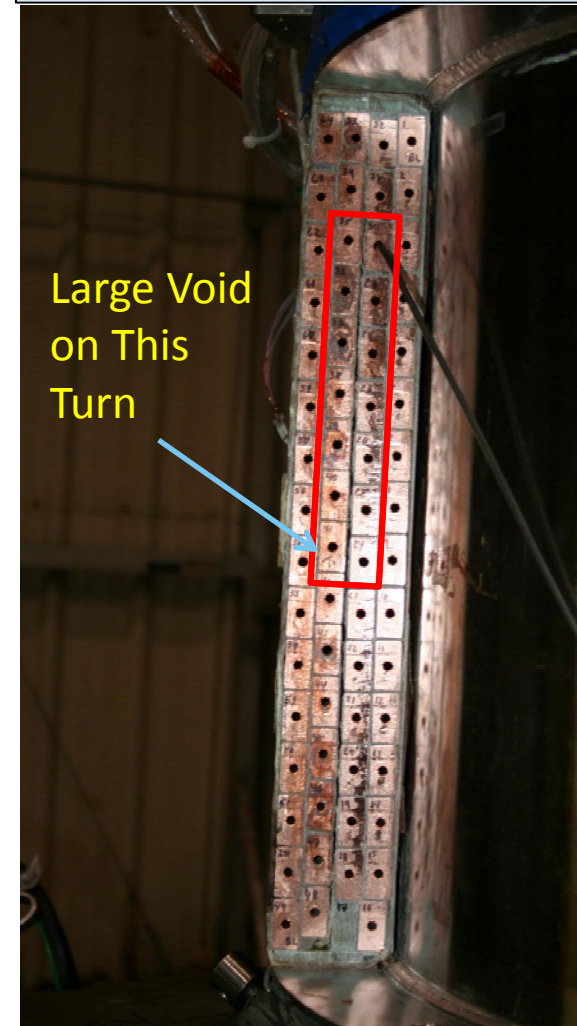
Region of Shorted Turns

- Technical Cause
 - Turn-to-Turn fault, most likely due to poor Vacuum Pressure Impregnation (VPI) plus other quality factors leading to turn-to-turn insulation breakdown
- Procedural Issues
 - Manufacturability of coil design
 - Inadequate QA and QC surveillance of manufacturing process at factory
- On-going investigations currently under way:
 - Reviewing VPI with experts in the field
 - Checking integrity of the conductor

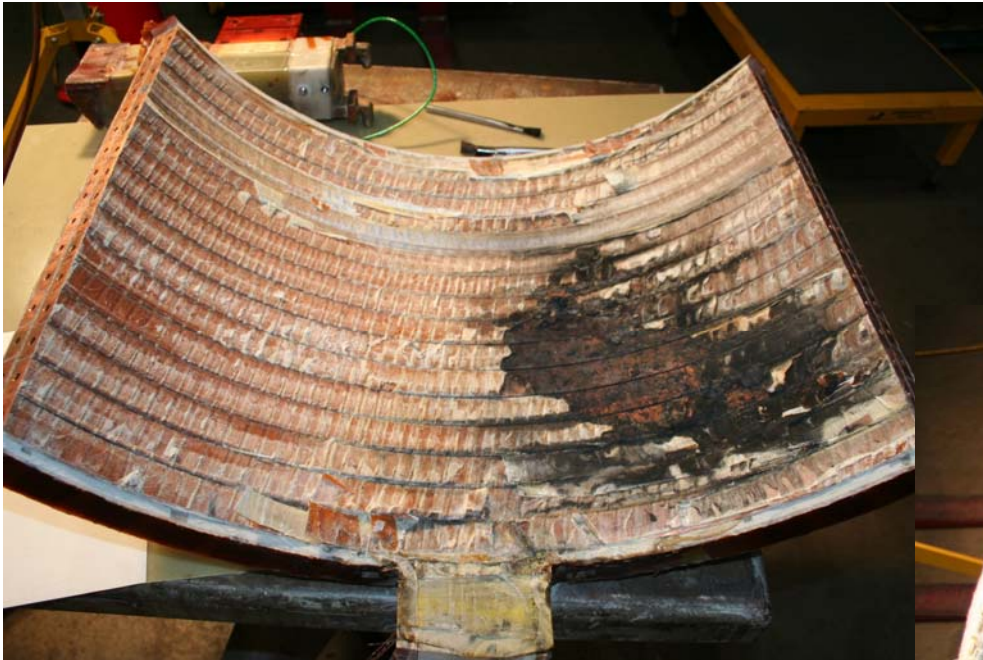
Coil Section with Fault Was Split Between Layers
