NSTX-U Recovery Project Review, Status and Plans

Presented at FESAC

February 1, 2017

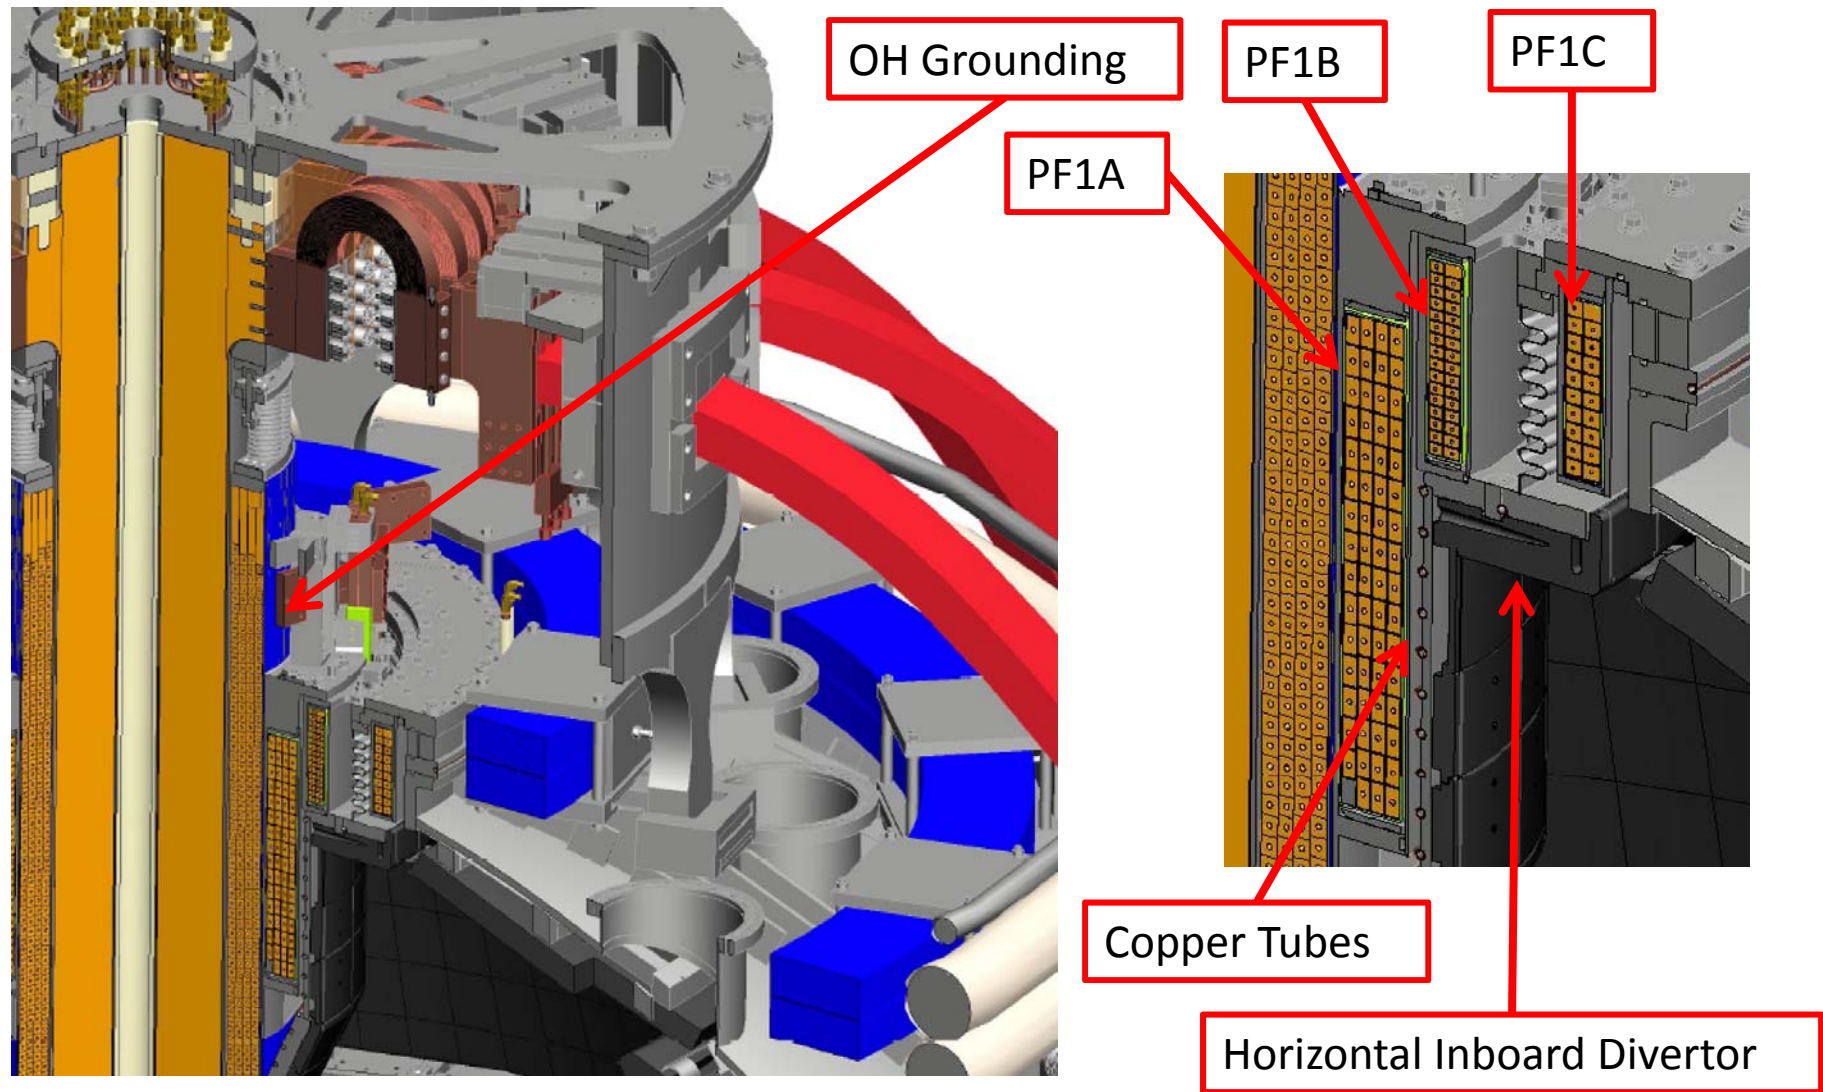
Region Where Problems Have Occurred

- NSTX-U has experienced a series of problems
 - OH “Arc Flash” incident – April 2015
 - Unable to bake inboard divertor PFCs at 350C – Sept 2015
 - PF1A Upper Bus Bar incident – May 2016
 - Center Stack Passive Structure Issues– May 2016
 - Failure of PF1A Upper coil – June 2016
- Each event can be attributed to a variety of Technical and Procedural Causes
- PPPL is conducting a broad investigation
 - Extent of Condition
 - Extent of Cause

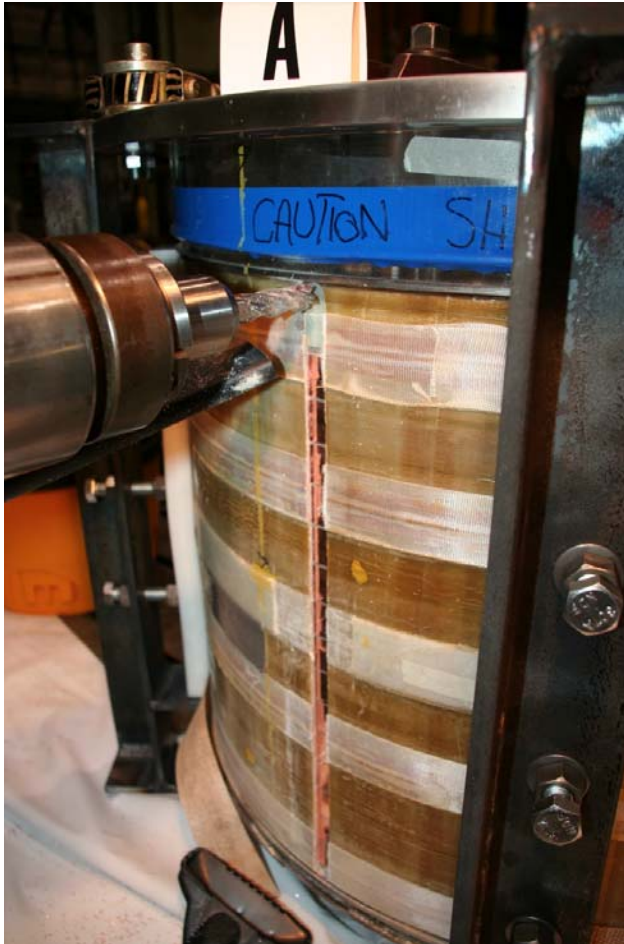
Coil Was Sectioned Using a Milling Machine

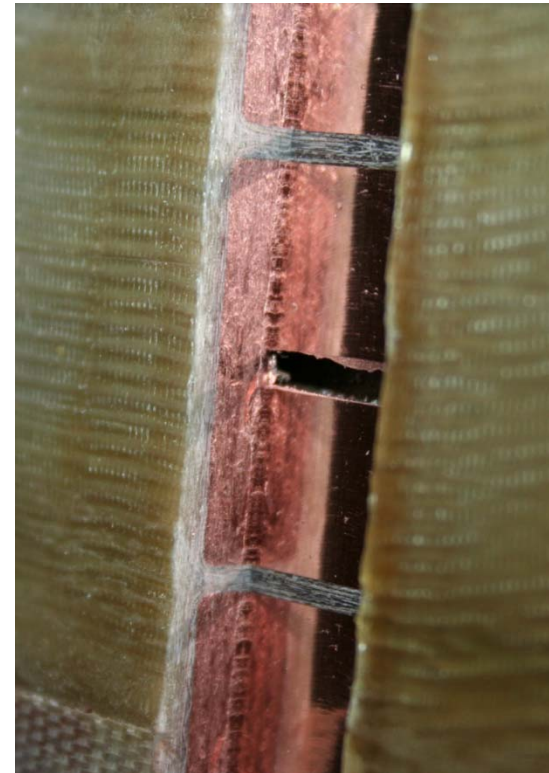
Section Planes Chosen to Avoid
Any Regions of Interest

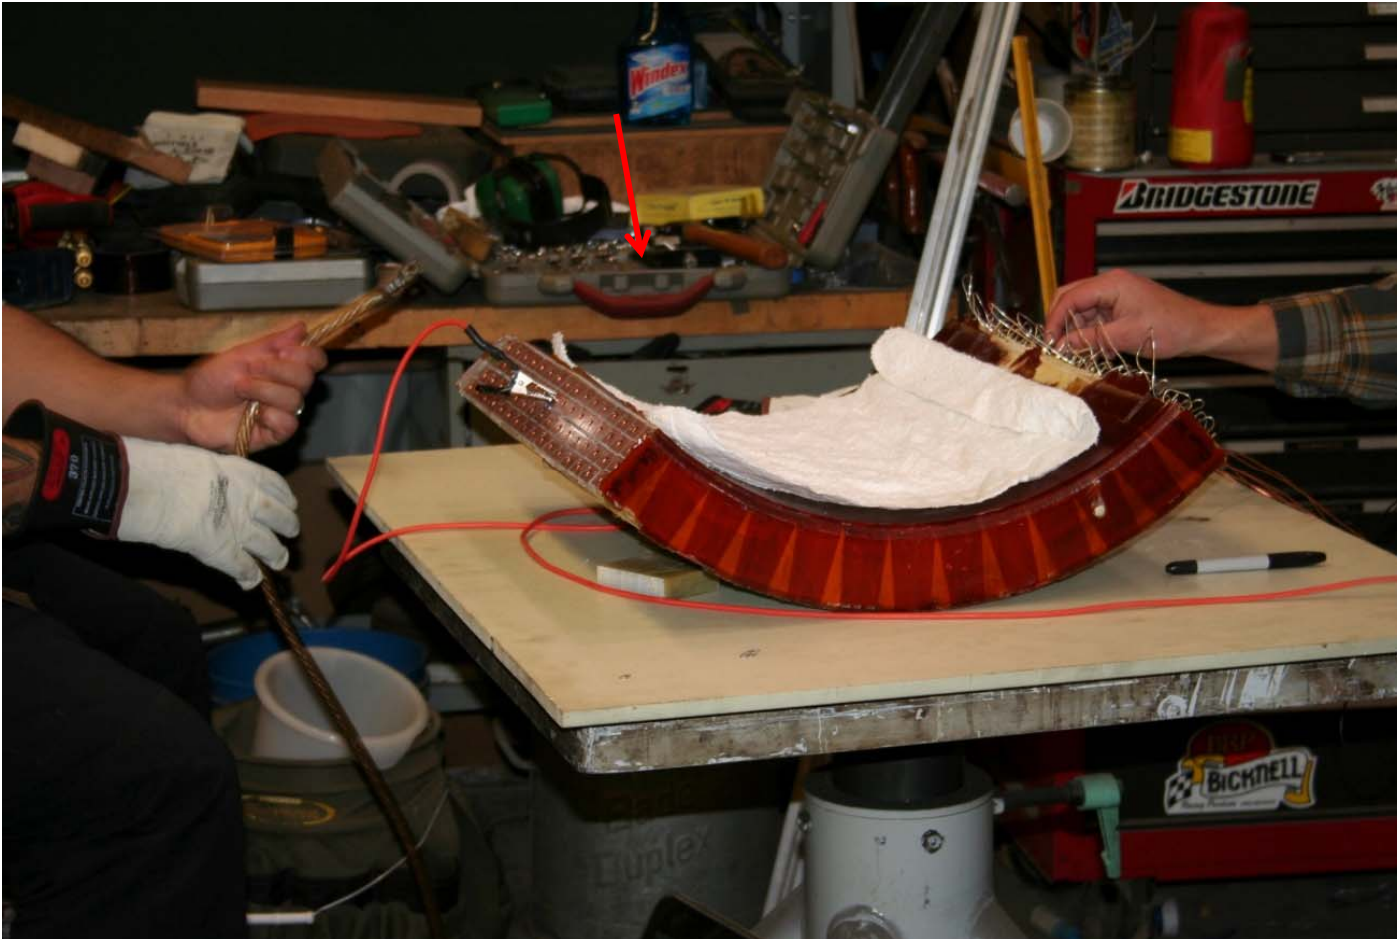
Electrical Tests

A Battery of Tests Was Performed on the Three Sections

Also vacuum & pressure testing of individual channels

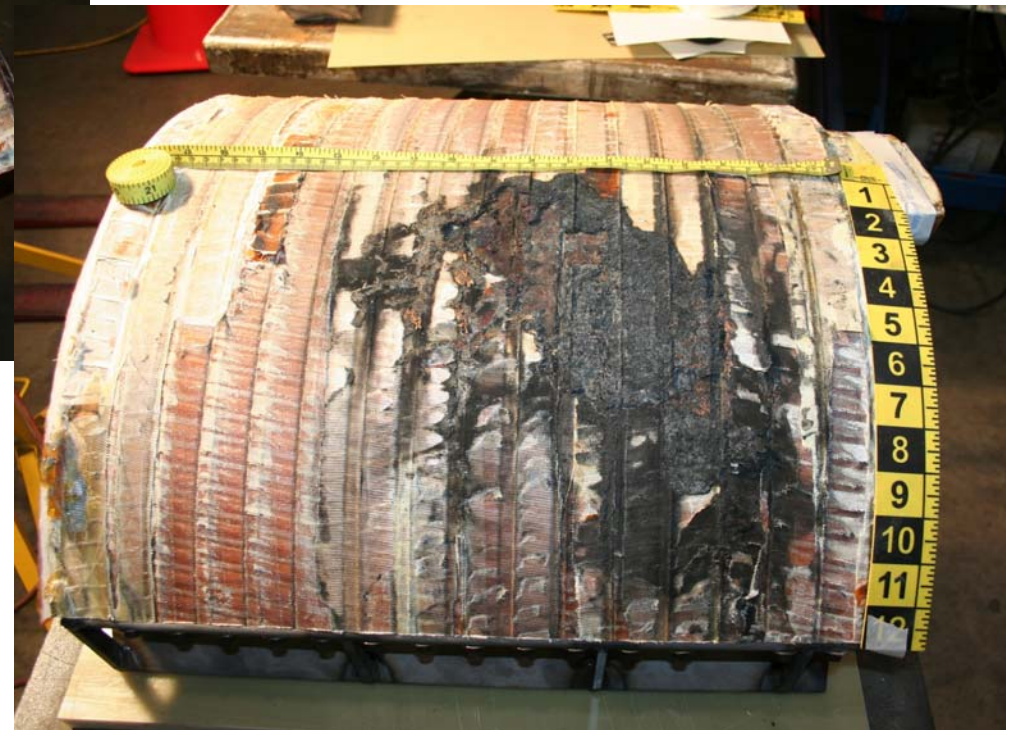
Concave Side

Coil Section with Fault Was Split Between Layers

- Technical Cause
 - Turn-to-Turn fault, most likely due to poor Vacuum Pressure Impregnation (VPI) plus other quality factors leading to turn-to-turn insulation breakdown
- Procedural Issues
 - Manufacturability of coil design
 - Inadequate QA and QC surveillance of manufacturing process at factory
- On-going investigations currently under way:
 - Reviewing VPI with experts in the field
 - Checking integrity of the conductor
